# AQUANOX A4382 Inline Process Stability Cleaning Case Study

**Background:** An OEM Energy Company has been struggling to achieve **consistent** cleaning underneath components with low gaps including QFN's, BGAs, and chip caps. This is even with using a high-powered inline cleaner. The inconsistency in the process has resulted in a very costly field failure due to flux contamination underneath a few low standoff devices. Past testing included IC results which registered below the industry accepted Anion and Cation limits during qualification, however, this was using the IPC B-52 Board without QFN's or the specific problematic AVX capacitor.

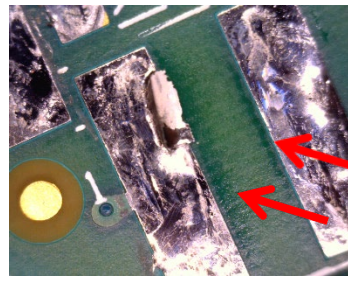
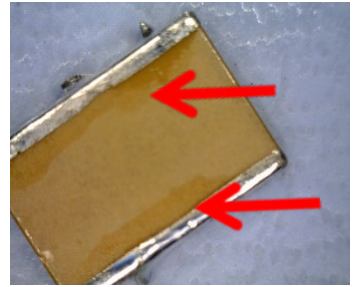
## Card #1 and #2

- All AVX Caps have Flux on the bottom side of the components.
- Both assemblies had flux on the PCB as well.

Board 1, C1 flux on cap underside and PCB

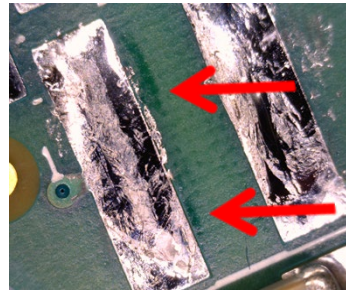
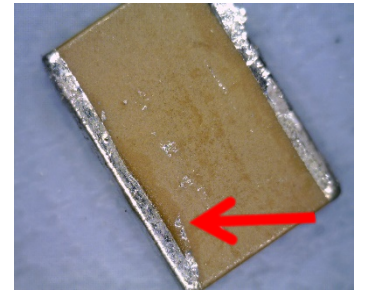
Board 1, C2 flux on cap underside and on PCB

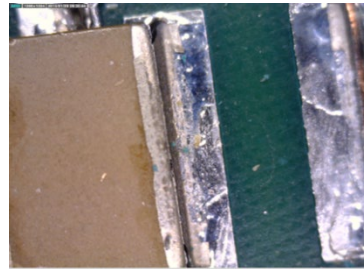
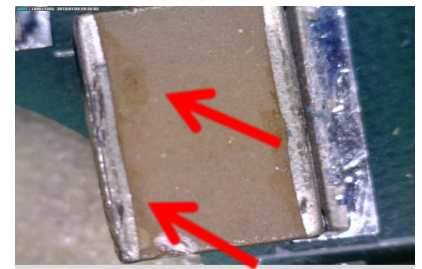
## Card #3 and #4 @1 foot per minute

- AVX Caps have Flux on the bottom side of the components.
- No flux residue on any of the PCB's under the components

Board 3, C1 flux on cap underside, no visual residue on PCB

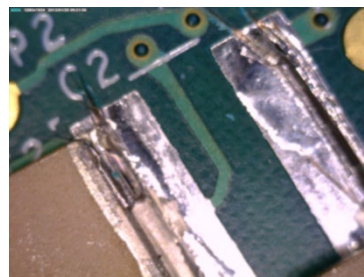
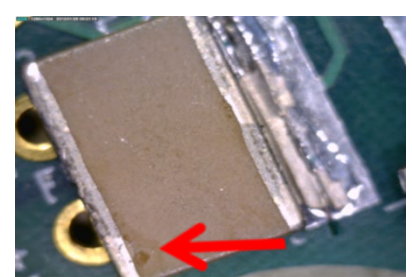
Board 4, C1 flux on cap underside, no visual residue on PCB

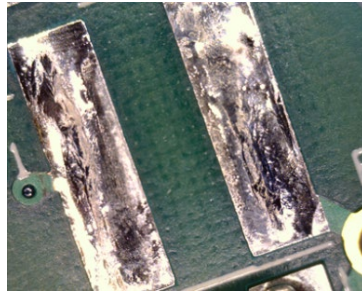
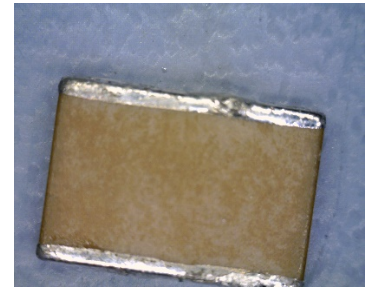
## Card #5 and #6 @ 2 foot per minute

- AVX Caps did not have flux residue on any of the components
- No flux residue on any of the PCB's under the components

*Board 5, C2 No Flux on cap underside, no visual residue on PCB*

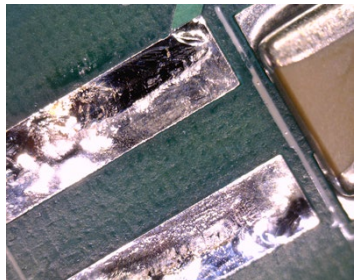
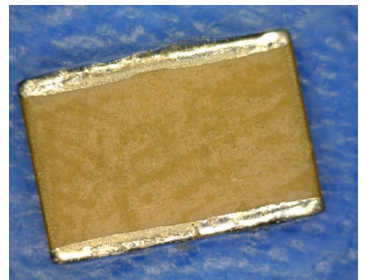
*Board 6, C2 No flux on cap underside, no visual residue on PCB*
